Manhole Inspection Summary

Manhole # S47MM_042MH

Insp Date: **3/9/10 1:24 PM**

Location Address: **Sinclair Ia**

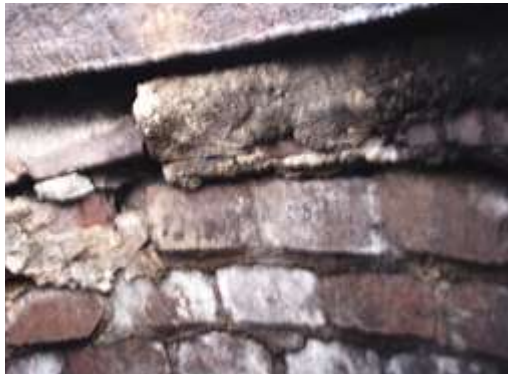
Defect 7

loose bricks

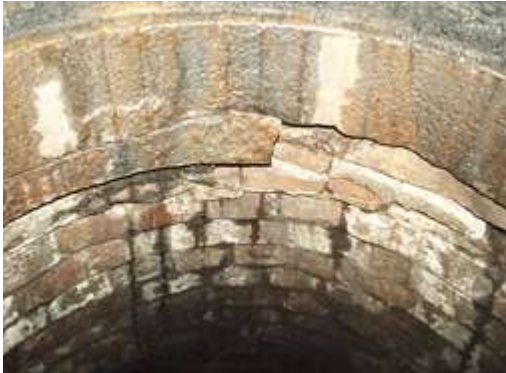
Defect 6

frame leaks

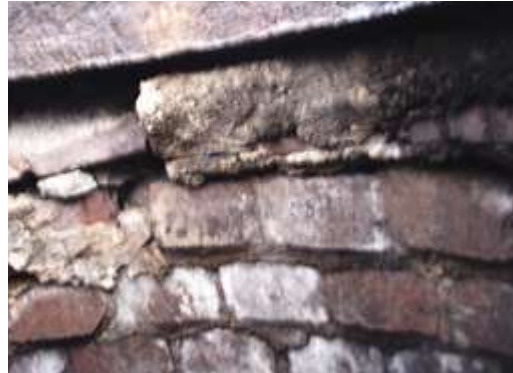
Defect 5

loose bricks

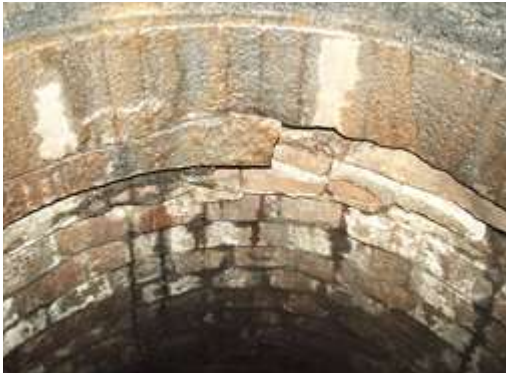
Defect 4

frame leaks

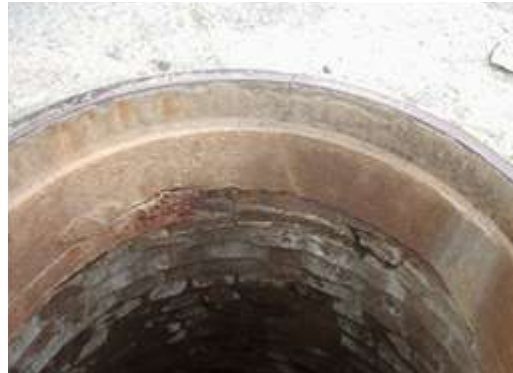
Defect 3

frame cracked

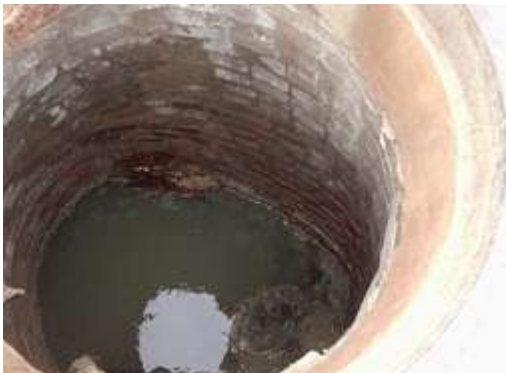
Defect 1

frame leaks

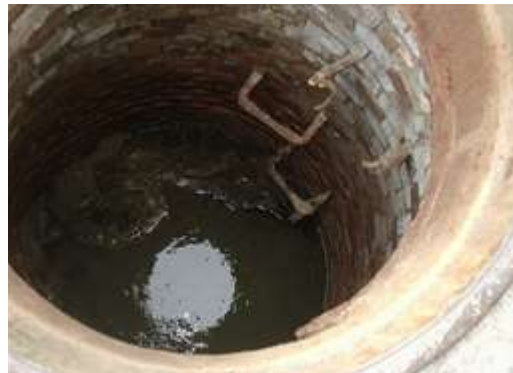
Defect 2

infiltration
